# National Register of Historic Places Inventory—Nomination Form

Historic Fort Washington also Fort Warburton

street & number Fort Washington Park n/a not for publication

state Maryland code 24 county Prince George's code 149

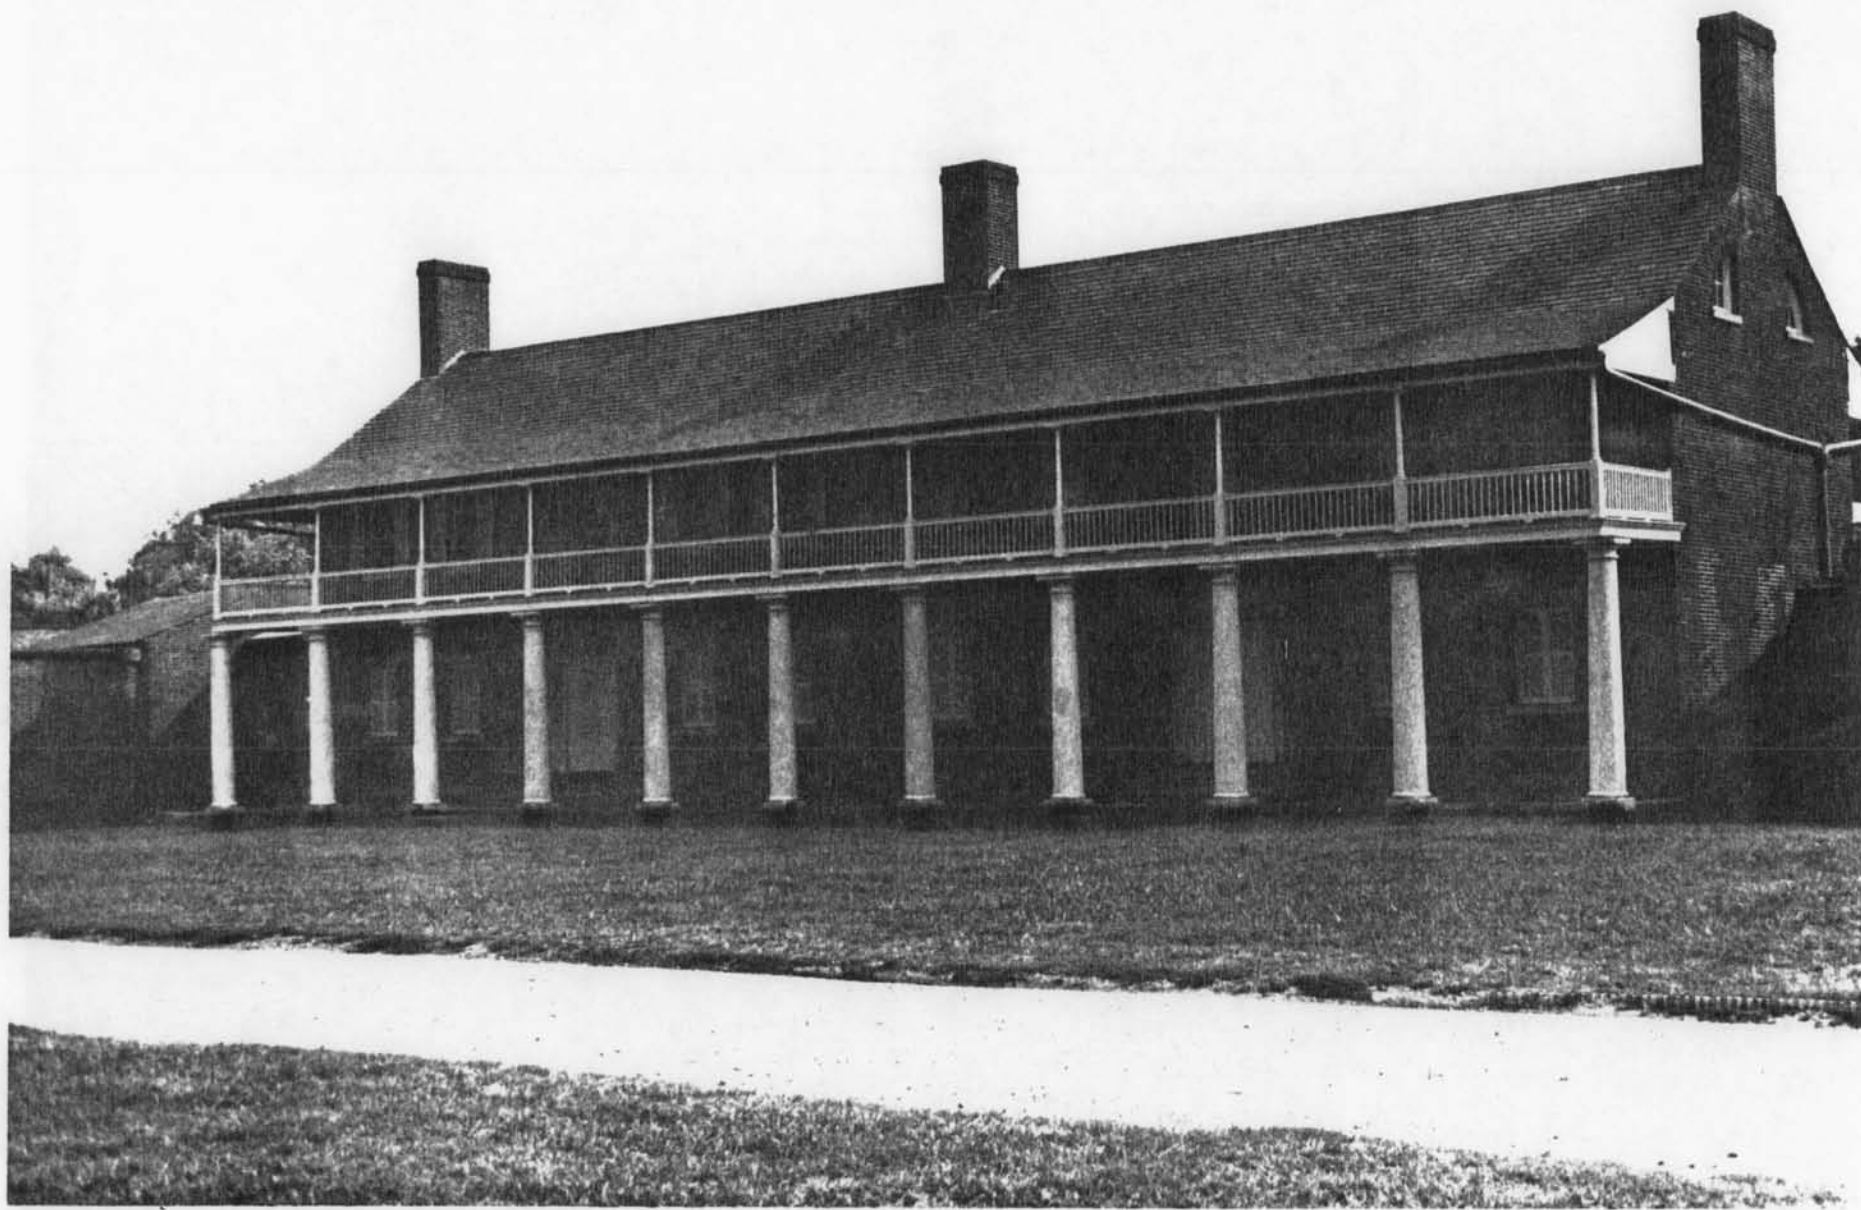
1. Officers' Quarters in Fort

The officers' quarters building is located inside the main walls of the fort, and faces west, paralleling the Potomac which is about 300 yards to the west. It is a long and narrow two-storey brick building with two end chimneys and one center chimney. The two principal entrances are at the west side, the northern one being a graceful exercise in federal style detail, with an elliptical fanlight, and sidelights flanking panelled doors. The south entrance on the west side was almost certainly a match, but now has its glazing replaced with boards.

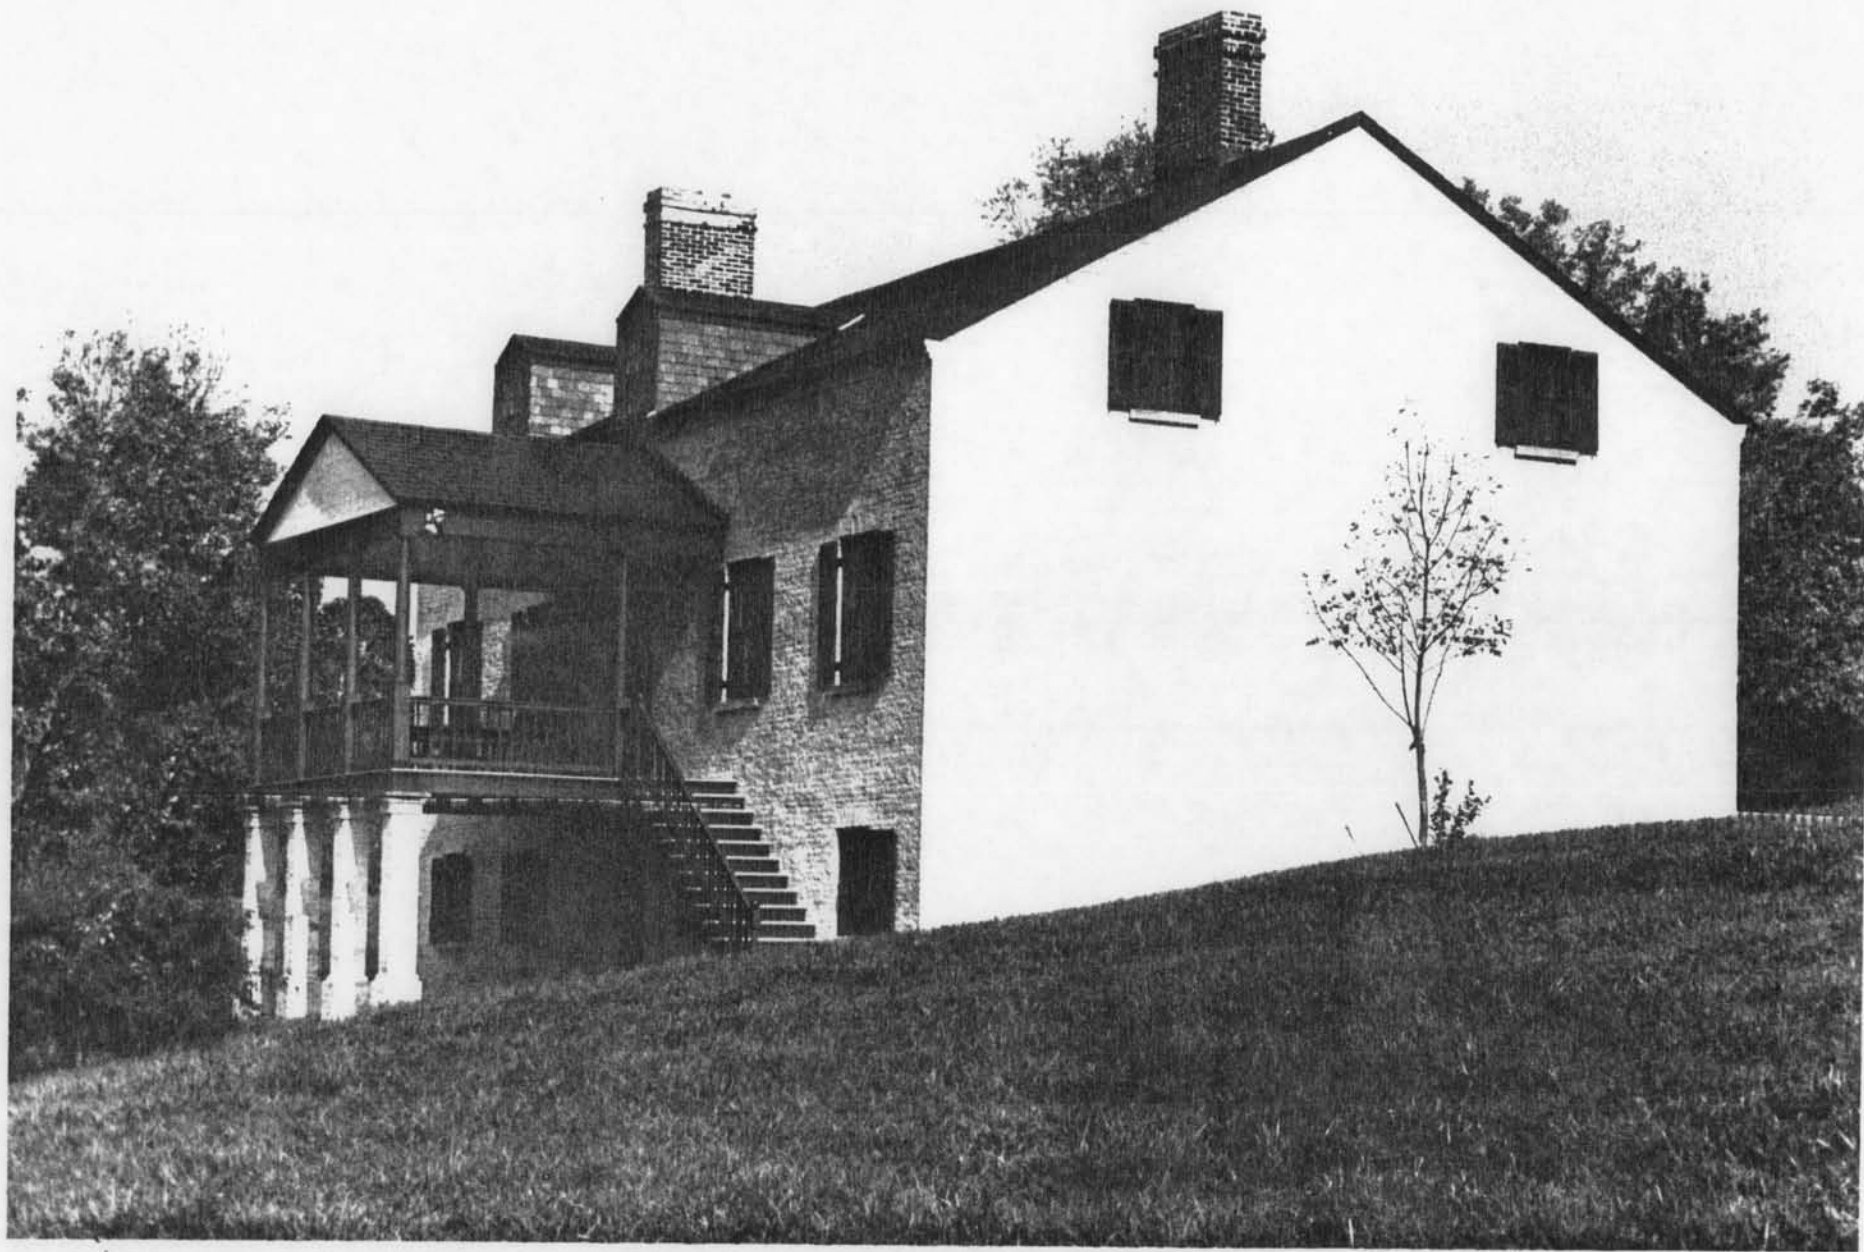
1. Commandant's House

Built around 1821, this is one of the most historic of the buildings at Fort Washington. This is a two-story brick house on a basement that is revealed from a little bit to almost fully, since the ground slopes away sharply around the house.

The house features two small dormers in the south side of the roof, and one small dormer on the north side.

A good bit of the interior architectural detailing has been lost to vandalism and/or neglect, i.e. chimney fronts, cornices, tiles, panelling, ballustrades, etc.

As the quarters for the principal official at the Fort, the commandant's house was the largest, as well as the most finely-detailed. It has been adaptively restored as a Visitors' Center for the fort. The restoration included replacement of both porches and the three historic dormers.

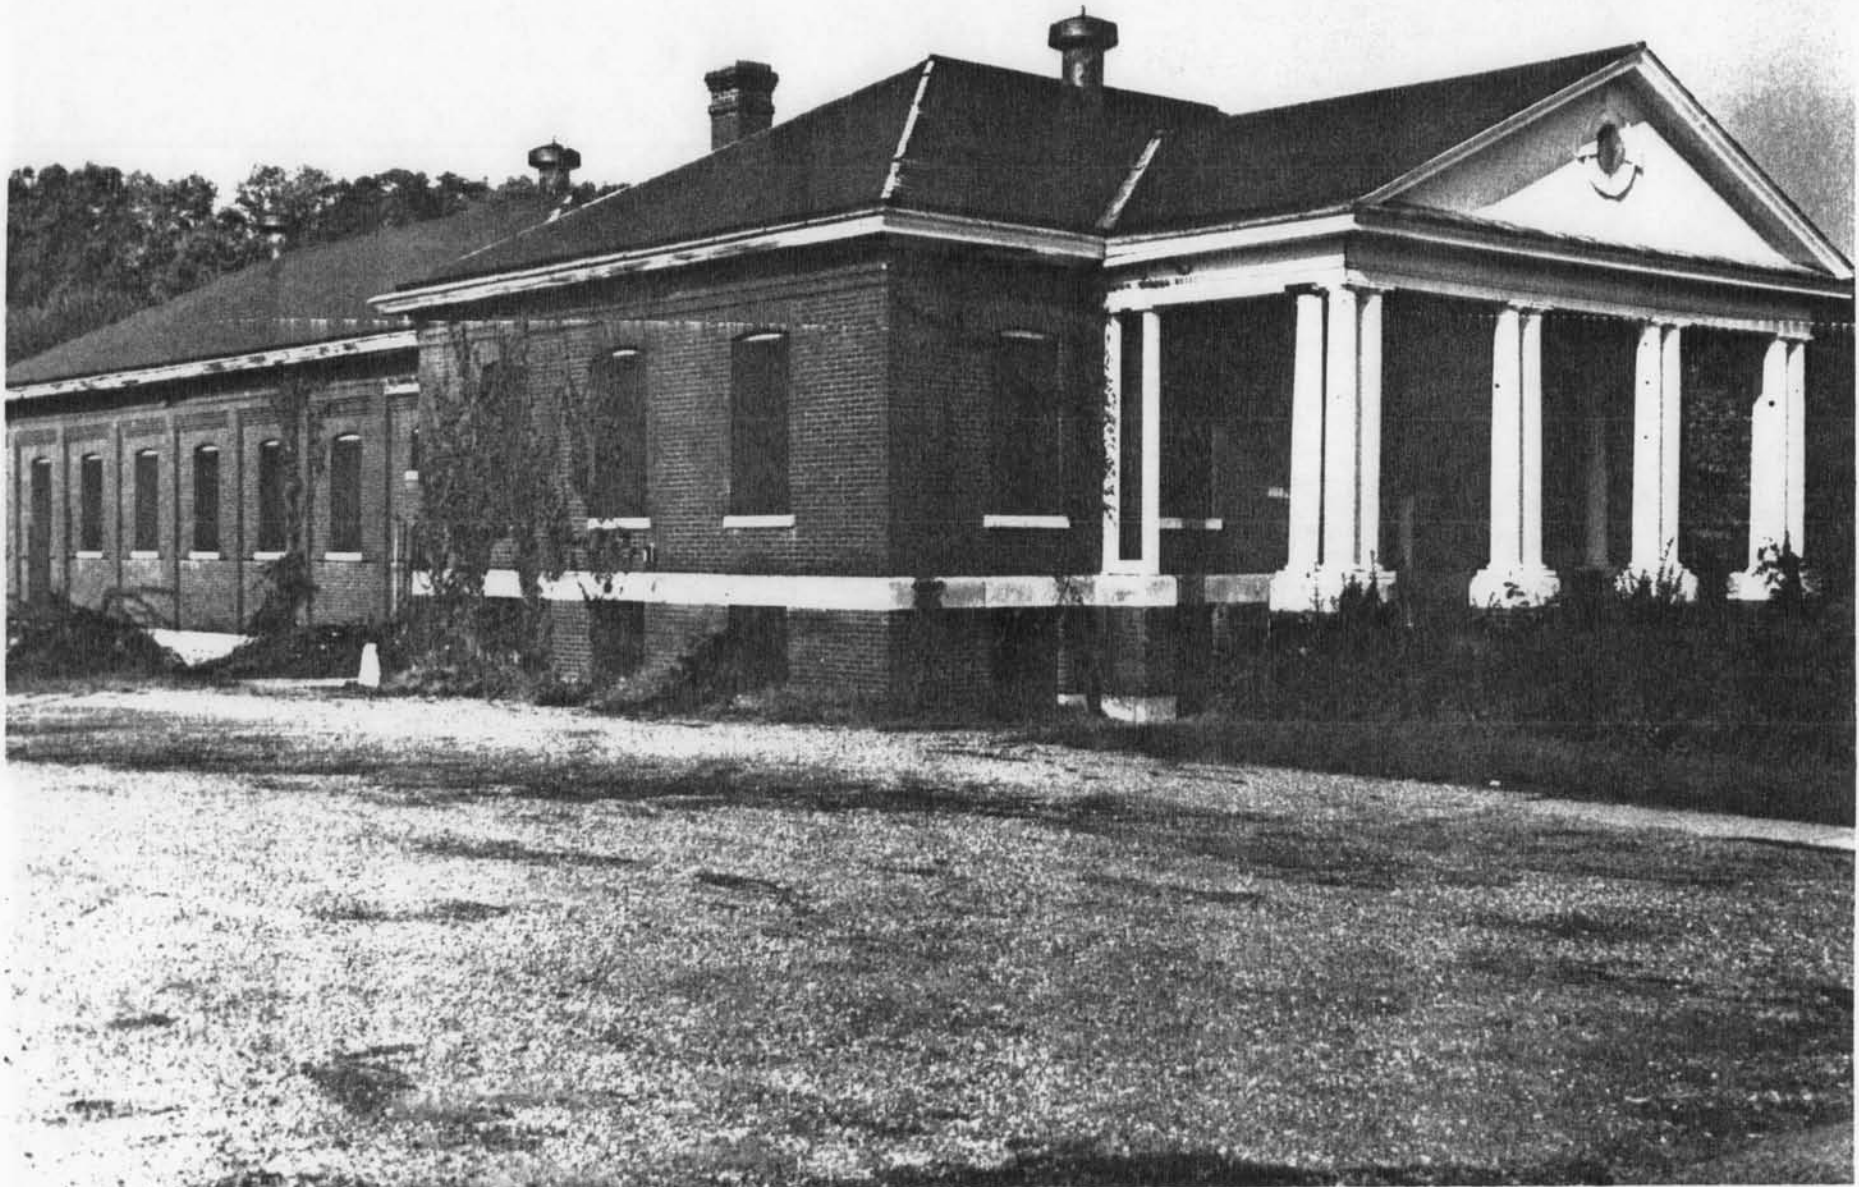
[REDACTED]  
1. PA Building

This is the largest of the remaining buildings outside the fort walls and is located in the center of the park close to the eastern boundary. It was constructed at a cost of \$24,444 and completed in June 1906. This structure, brick on a stone foundation with slate roof, measures 103' x 51' and contains 6344 square ft. The front winged portion, 51' x 37', has two floors with twelve rooms. The rear portion is one large room, 34' x 75', which housed the gym. In 1933 the structure was remodeled and a portion was used as a school. During World War II the structure became the post headquarters building.

To date, the structure is essentially intact; some exterior brick and stone have fallen out and the wooden classical portico over the main entrance is in disrepair. The interior shows a great deal of deterioration.

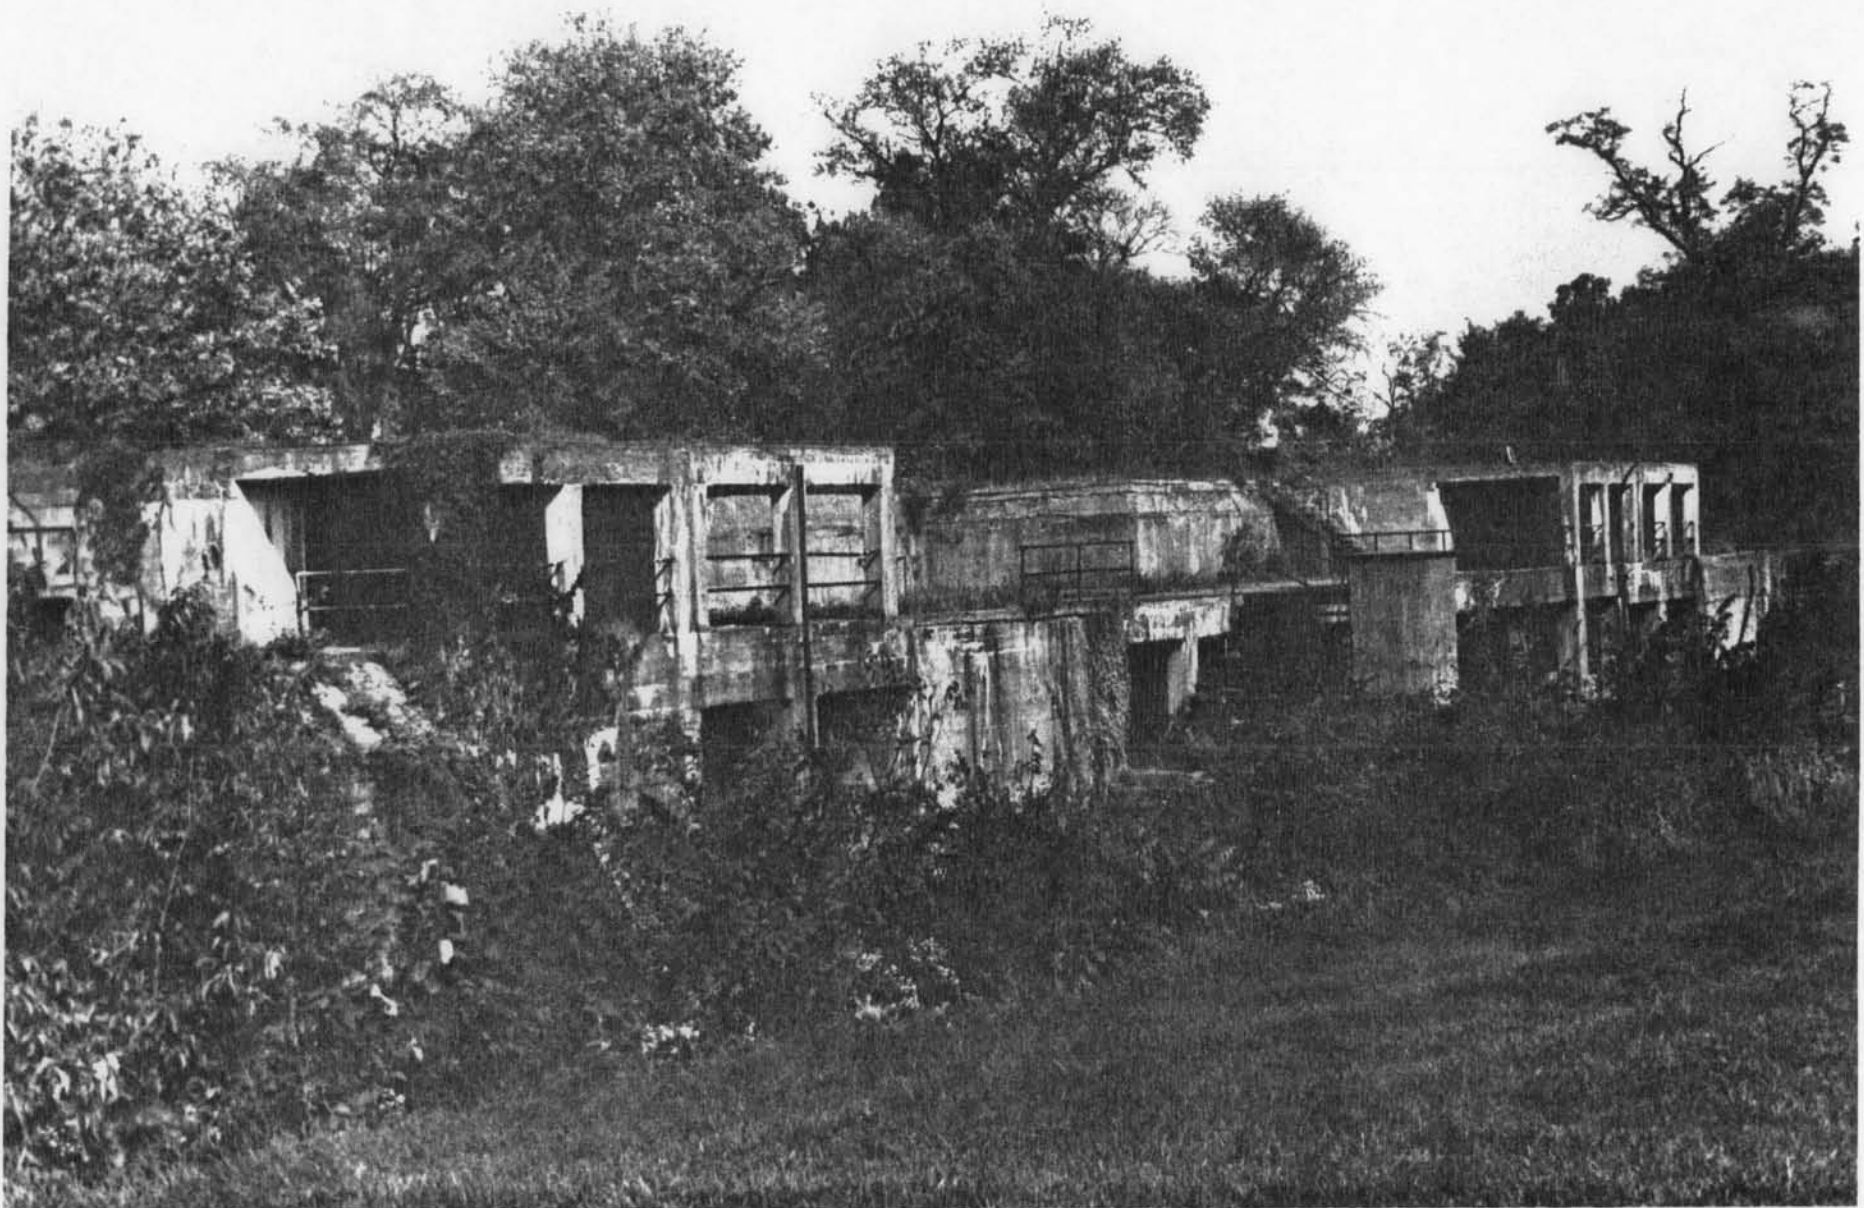
1. Battery Decatur

It is approximately 330' x 90' and designed for two 10" disappearing rifles. Battery Decatur is located immediately to the north of Fort Washington and is named for Commodore Stephen Decatur, U.S. Navy 1798-1816. The emplacements consist of each rifle mounted behind an 8' high protective concrete wall above a circular passageway system immediately beneath the gun pit. At this Battery the storage areas are double level below the guns and are protected by a 3' thick reinforced suspended slab. The general appearance of the Battery shows considerable cracking and leaching of the East spandrel beam supporting the upper platform and also considerable leaching of the upper protective roofs above the ammunition handling areas. The lower walls of the storage areas show considerable water infiltration and are wet and the upper walls surrounding the gun emplacements themselves show a great deal of spalling of the concrete surface, as if the surfaces were refinished at some time subsequent to the initial construction and this finishing layer is deteriorating now and spalling away from the walls.

The physical condition of the battery varies from section to section. Some areas are in good condition while others show erosion of the concrete up to 1½" in depth. Some I-beams are badly rusted due to water infiltration. The battery is fenced in and closed to the public.
